MACHINE SERVICE BULLETIN #112

SUBJECT: Lock for Clear-out Mechanism "C" and "E" Models

DATE: March 6, 1931

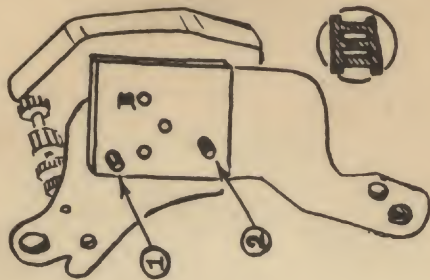
Place the drill jig on the motor bracket with the side of the jig marked A, out. Pins 1 and 2 of the jig should be located in the holes in the motor bracket as shown in figure 1 of the attached sketch. Drill holes A, through the motor bracket with a #32 drill. If the drill starts to chatter after the holes are started, remove the jig and complete the drilling without the jig, and thread these holes with a #6-40 tap.
